STONE ANALYSIS & MATCHING REPORT

AP 3759
Poosie Nansies, Loudoun St,
Mauchline

Sample 1
Sandstone

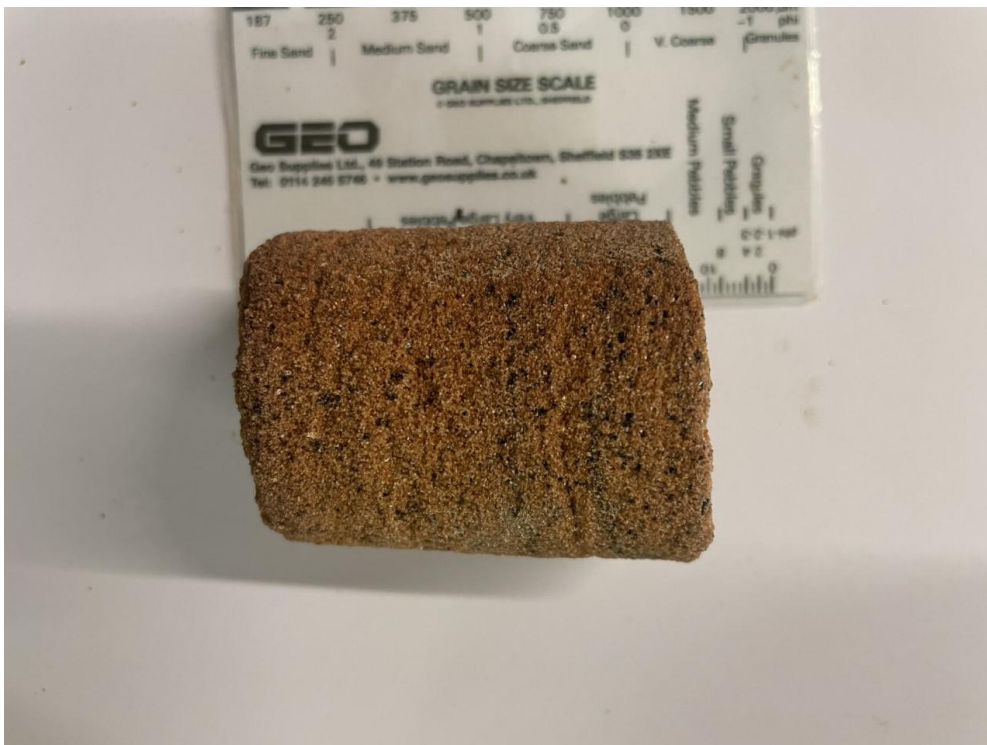
Plate 1. Image of the sample as received. Note the black speckling caused by Fe-oxides. Scale is in mm.

In hand specimen the sample showed some slight discolouration on the exposed stone face, measuring 2.5YR 5/3 'reddish brown' with the fresh faces appearing 2.5YR 4/4 'reddish brown' to 2.5YR 6/6 'light red' when assessed against the Munsell Soil Colour Charts. The sandstone is generally fine to medium grained, appearing texturally sub-mature to mature and mineralogically mature to sub-mature. The stone is composed of similar sized, sub-angular to sub-rounded and rounded haematite-stained quartz grains, occasional Fe-oxides and carbonaceous flakes (both creating the slightly speckled appearance) and lighter coloured grains (possibly feldspar or lighter coloured quartz) bound by occasional and well distributed intergranular quartz overgrowth silica cement. Haematite staining of quartz grains provides the stone with its distinctive red colour in hand specimen. It experienced a moderate to strong reaction when subjected to 10% hydrochloric acid (HCL), likely from a carbonate cement and carbonate lithic fragments. The received sample displays a predominantly uniform texture with little evidence of layers/laminations, however it may display bedding on a larger scale not visible in hand specimen. The stone experienced a moderate water absorption rate when subjected to the water droplet test, signifying a discontinuous internal pore network.

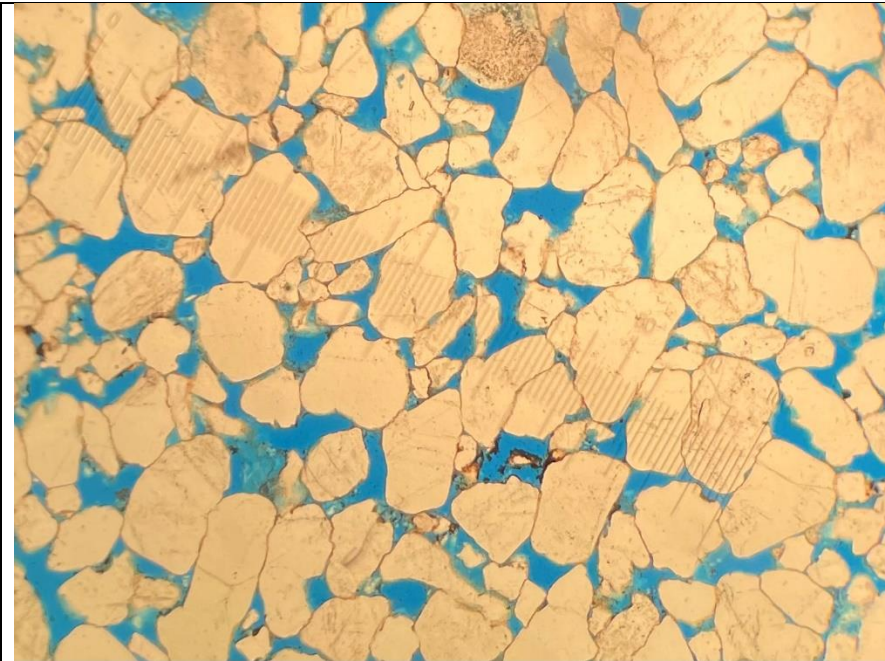
Field of view is 4.2mm.

Plate 2. Thin section of the sample under plane polarised light. Pore spaces are highlighted in blue, while areas of light blue indicate pore filling clays that have absorbed some of the blue dye. Pores are moderately to well connected, with some of the larger pores filled with small, sub-angular to sub-rounded quartz, feldspar and lithic fragments.

Porosity and permeability: The stone has a moderate visual porosity, estimated between 10-13%. Concentrations of Fe oxides and carbonaceous matter will act to significantly increase the tortuosity of the pore network, which will also impact on moisture movement through the stone. Small pores are evident between the smaller grains due to poor grain sorting, while larger pores are found between the larger grains in the main stone matrix, but are commonly filled with small, angular quartz grains and kaolinite clay.

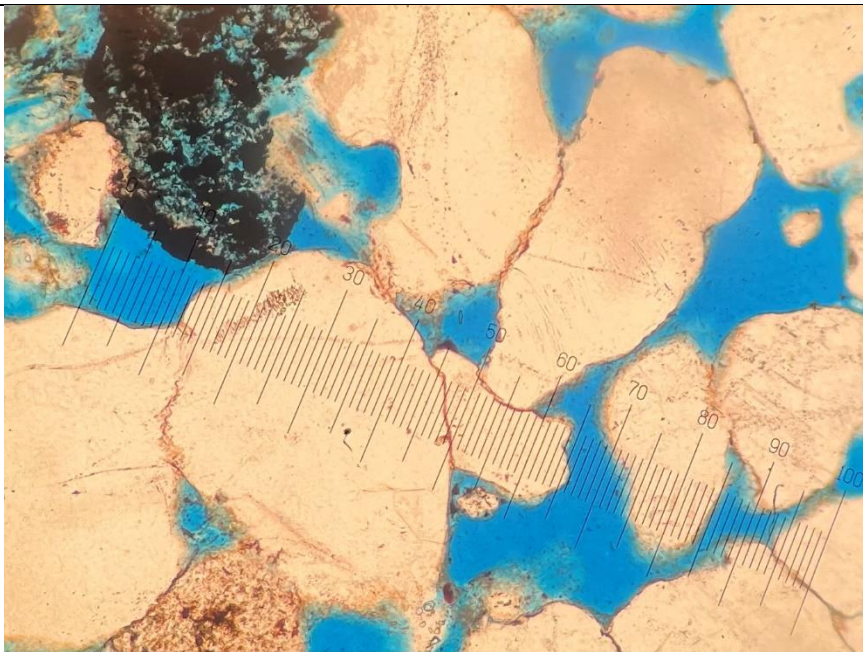
Field of view is 1.2mm.

Plate 3. Thin section image of the sample under plane polarised light. Pore spaces are highlighted in dark blue, while areas of light blue indicate pore filling clays. There are some concentration of Fe oxides and organic carbonaceous matter within the thin section. Fe staining can be seen surrounding some of the quartz grains, which gives the sample its red colour.

Texture: Bedding planes are not evident within the thin section however, it could be that within this sample the beds are thicker therefore not seen at this scale. There are some areas of concentrated Fe oxides and carbonaceous matter which impart the speckled appearance to the stone in hand specimen. The permeability and porosity are decreased in these areas, owing to the increase in grain compaction, pore-filling clays and the decrease in grain and pore size. The surrounding stone matrix is composed of medium-grained, moderately compacted, sub-rounded to rounded quartz, feldspar and lithic fragments.
